TECHNICAL MEMORANDUM

Warm Springs Commercial Corridor Safety Plan

DRAFT Existing Conditions Memorandum

Date: November 17, 2016 Project #: 19780
 To: Lonny Macy, Confederated Tribes of Warm Springs
 From: Ashleigh Griffin, AICP, and Brian L. Ray, PE
 cc: Michael Duncan, ODOT

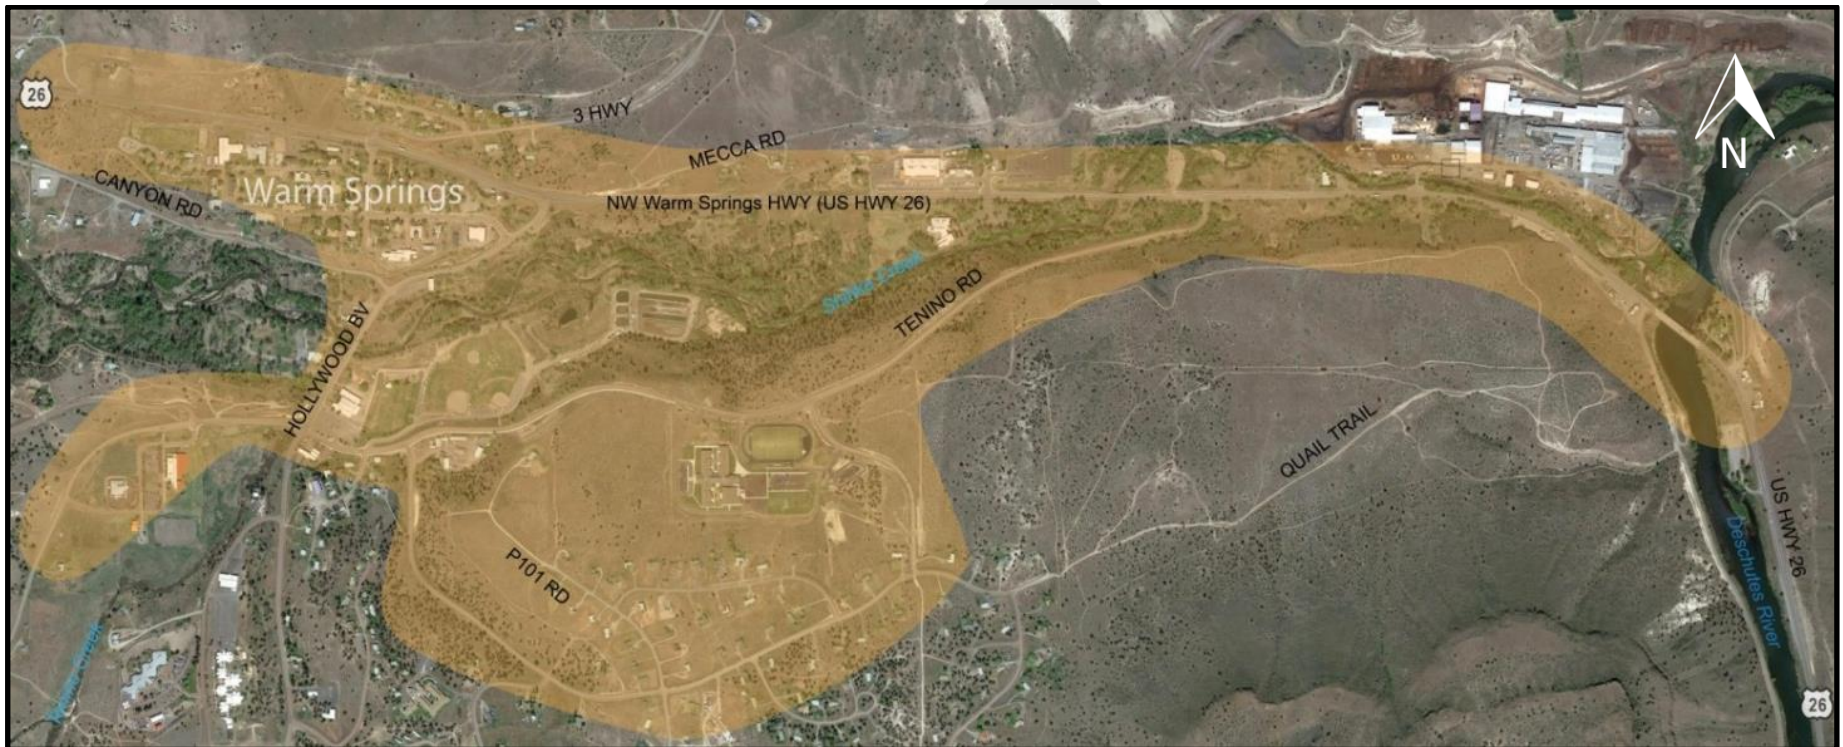
Figure 1. Study Area

The Plan focuses on an approximately three mile section of US 26 from the intersection at Paiute Avenue (BIA 3) to the southeastern boundary of the reservation at the Deschutes Crossing (milepost 105.20) and nearby streets, as illustrated in Figure 1.

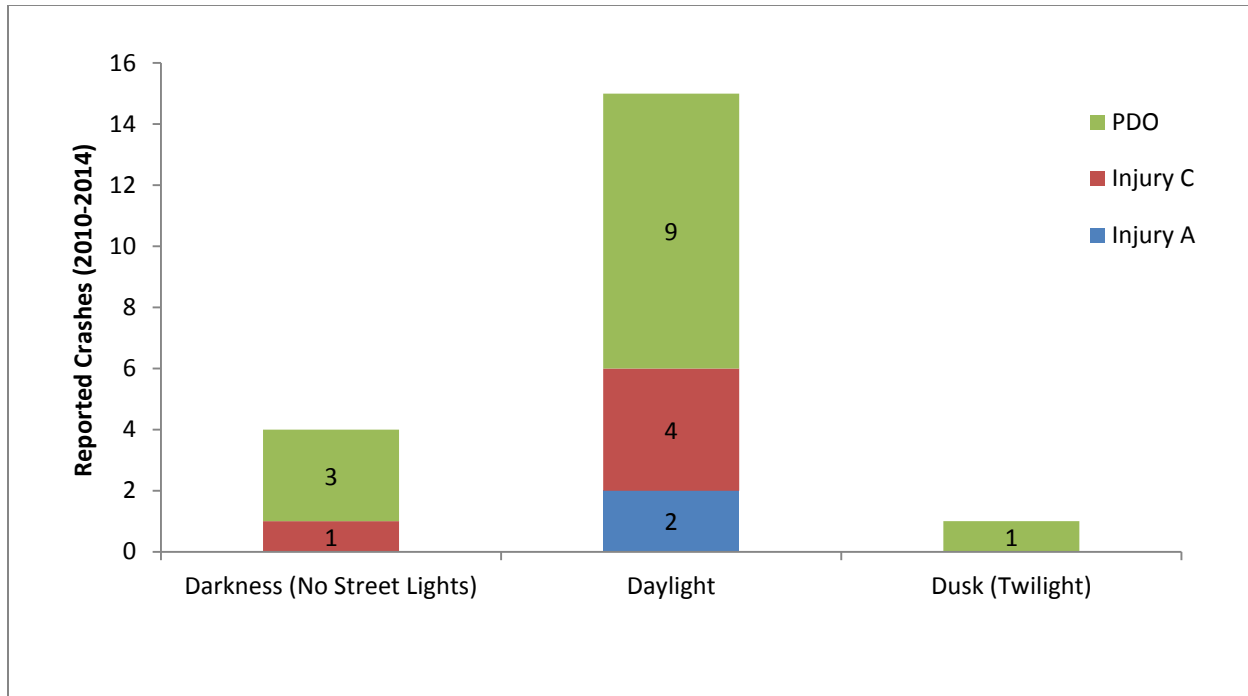
Figure 9. Number of Reported Crashes in US 26 Corridor by Light Condition (2010-2014)

Figure 9 illustrates that the majority of crashes occurred during daylight conditions. Four reported crashes occurred during dark light conditions, and one crash occurred at dusk. The majority of injury crashes also occurred during daylight conditions.

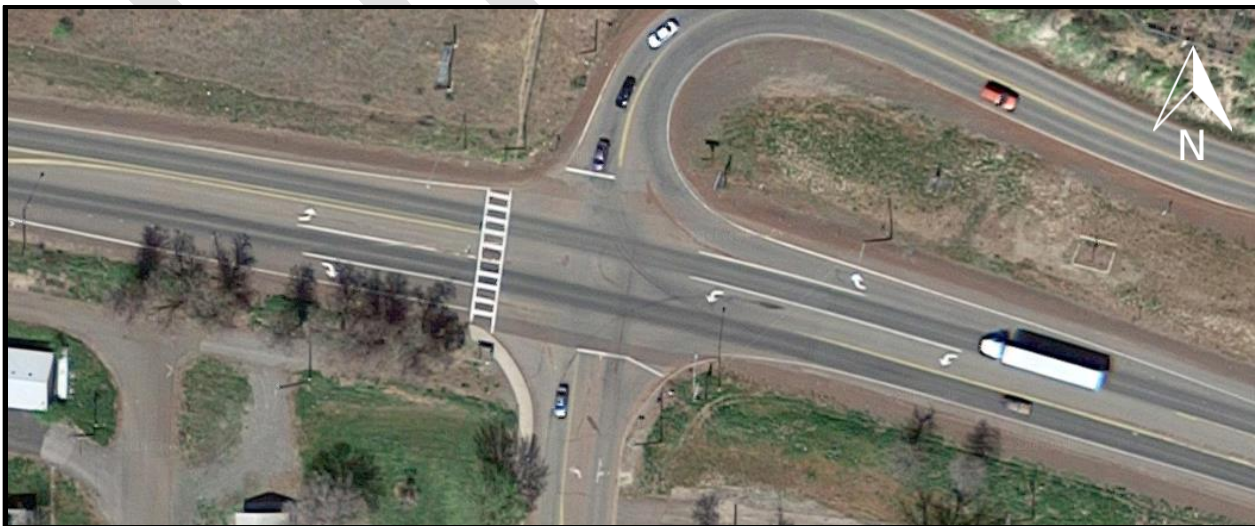
Figure 13. Existing Intersection Configuration of US 26/Paiute Avenue (Source: Google Maps)

The US 26/Paiute Avenue intersection is a minor street stop-controlled, four-legged intersection. This is the first major intersection eastbound drivers encounter on US 26 within the Warm Springs area. BIA 3 extends north from US 26 at this location, providing connections to employment locations including the Kah-Nee-Ta Resort and therefore carrying relatively high amounts of traffic. Figure 13 shows the existing intersection configuration.

Eight crashes were reported at this intersection during the study period, including one severe injury crash. The remaining seven crashes did not result in an injury. Rear-end crashes and angle crashes were the most common reported crash types, with three crashes each. The severe crash was an angle crash. There was also one turning movement and one backing crash reported. Two reported crashes occurred during snow conditions; the remainder occurred during dry conditions. One crash occurred during dark lighting conditions.

Directionality of the crashes was further reviewed to determine if one direction was overrepresented in the reported crashes. Among the three reported angle crashes, one crash involved southbound and eastbound vehicles, one crash involved northbound and westbound vehicles, and one crash involved southbound and westbound vehicles. Among the rear-end crashes, two crashes involved southbound vehicles and one crash involved westbound vehicles. The turning movement crash involved westbound and eastbound vehicles. The backing crash involved a southbound and northbound vehicle. The two southbound rear-end crashes may be associated with the sharp curve located on the approach to the intersection.

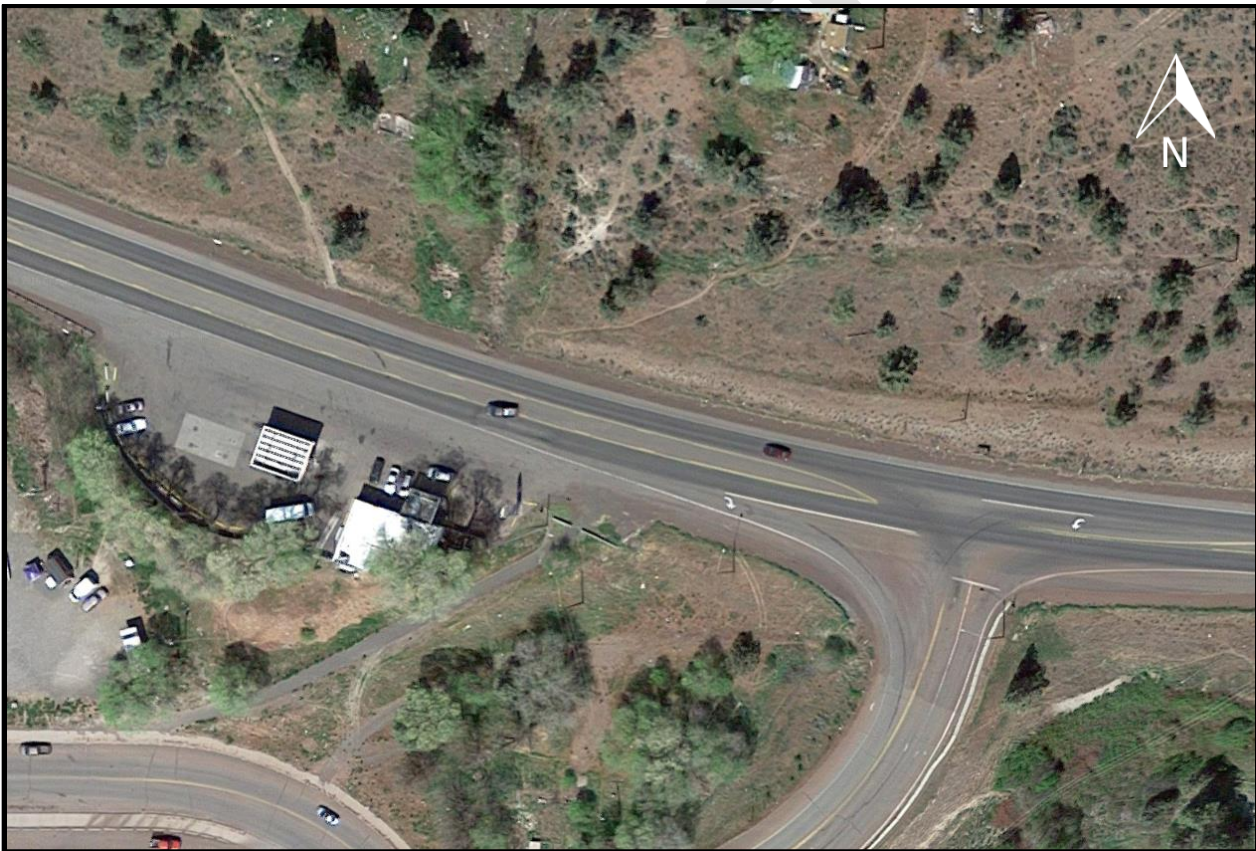
Figure 14. Existing Configuration of the US 26/Hollywood Boulevard Intersection

The US 26/Hollywood Boulevard is located a short distance from the driveway area to the gas station. Therefore, this location is reviewed together. Four crashes were reported at this location between 2010 and 2014. In addition, the partial 2015 crash data indicates an additional two crashes that occurred near the gas station driveway.

One of the four reported crashes resulted in a severe injury, and one crash resulted in a minor injury. The remaining two crashes did not result in an injury. The four reported crashes occurred during dry, daylight conditions. Two crashes were reported as turning movement crashes, and two were rear-end crashes. The two turning movement crashes involved vehicles traveling eastbound in conflict with vehicles turning from the south. The two rear-end crashes occurred in the westbound direction.
