Technical Memorandum #2- Existing System Conditions and Future System Needs Assessment

Date: September 30, 2015

Subject: Klamath Falls Urban Trail Master Plan - Existing System Conditions and Future System Needs Assessment

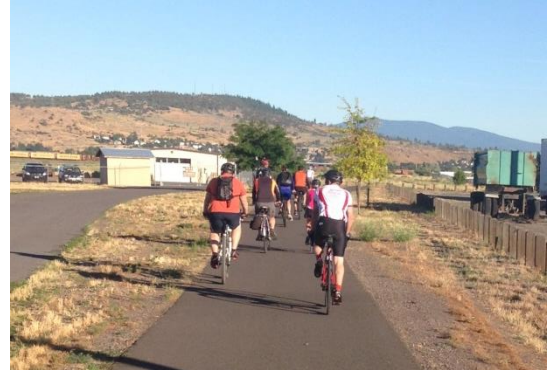
OC&E Trail West of Washburn Way

- **OC&E Trail** – This is a rail-to-trail conversion in the former railbed of the Oregon, California, and Eastern Railroad. The trail extends east from Klamath Falls to the community of Olene, before heading northeast to Bly and the Sycan Marsh Preserve. Within the Klamath Falls UGB, the OC&E Trail is 7.5-miles long and runs through neighborhoods in the central and eastern portions of the urbanized area. It nearly connects these neighborhoods to downtown Klamath Falls, but currently ends at the still-active rail tracks east of downtown. The OC&E Trail is maintained by Oregon State Parks.

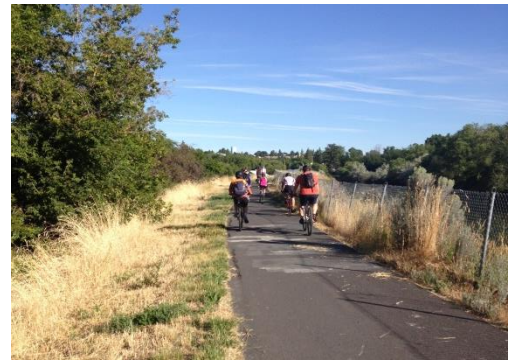
“A” Canal Trail West of Washburn Way

- **“A” Canal Trail** – This paved trail, owned by the Bureau of Reclamation, parallels the “A” Canal from Homedale Road in the southeast portion of the urbanized area to Esplanade Avenue north of downtown Klamath Falls. Because the trail is located adjacent to the canal it is grade separated from many of the surrounding neighborhoods. The “A” Canal Trail is 4.1-miles long and crosses the OC&E Trail east of Summers Lane. A ¼-mile connection along Crater Lake Parkway is necessary to reach the Crater Lake Parkway Trail.

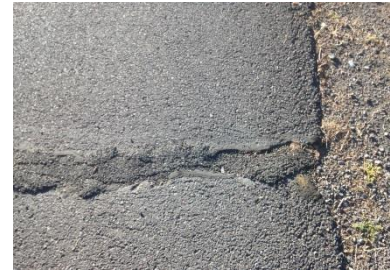
- OC&E Trail (generally good condition inside the UGB, although thermal cracks are starting to become present)
- Campus Trail (generally good condition, but a mix of surfaces including concrete and asphalt)
- “A” Canal Trail (generally poor with minor thermal cracks occurring every 40 to 50 feet and major thermal cracks, large bumps, and pot holes occurring every few hundred feet. We understand some people avoid bicycling on the trail due to the presence of large cracks that tend to be repetitive and hard on bikes. In addition, the ramp crossings can be difficult to navigate for novice cyclists)

Patched Crack on OC&E Trail

The usual asphalt distress for multi-use paths is the occurrence of thermal cracks. These cracks are the response of the asphalt to hot, cold, and oxidation of oil over the lifetime of the asphalt. In addition, original construction techniques also influence certain failure mechanisms for asphalt. For instance, it is our understanding that the “A” Canal Trail is a thin lift of asphalt over marginal base. The presence of adjacent water may have also affected the compaction of the subgrade soils and aggregate base. The “A” Canal Trail has the most thermal cracks and pot holes of the local trails.

The goal of any maintenance program is to proactively address declining conditions as soon as possible. Such a program achieves the least cost for maintenance over time and the best condition possible. If maintenance is neglected past a certain point, then more expensive rehabilitation techniques are necessary. For example, related to roadways, chip seals are the least cost method for maintaining a road and cost around \$0.25 per square foot, compared to \$2.00 per square foot for a two-inch overlay or \$8-\$10 per square foot for a full roadway rebuild. The catch is that a chip seal program has to be started early in the life cycle of a roadway, it is not a fix all for roads that have alligator cracked. The life cycle costs for a 20 year program for a rebuild is \$8-\$10 per square foot, while the same life cycle cost for a chip seal would be less than \$1 per square foot, assuming a 7 year cycle (i.e. chip sealing would occur approximately 3 times in 20 years).

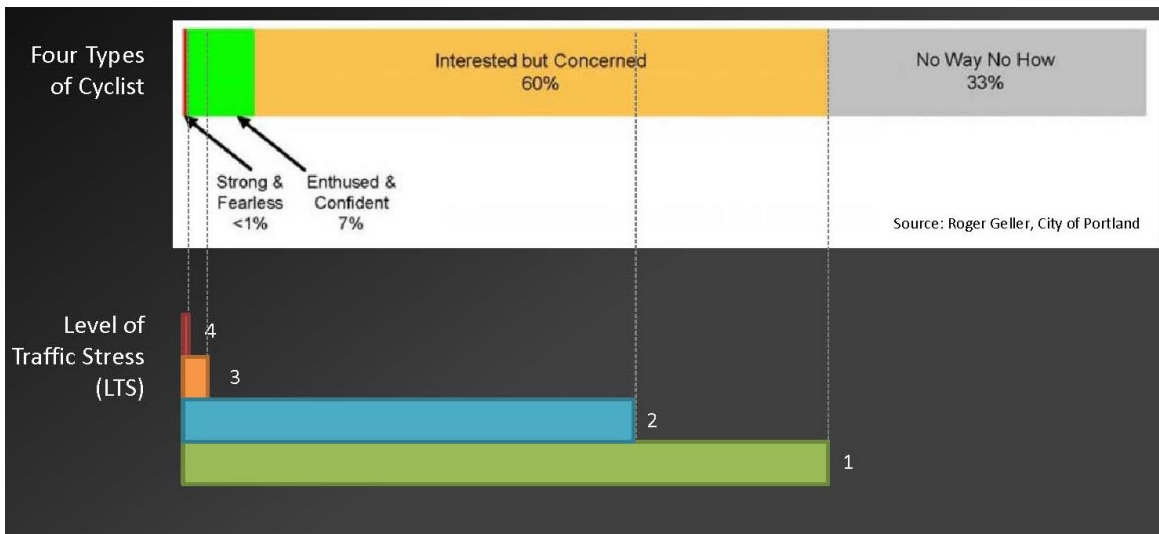
How LTS Relates to the Type of Person Who Might Ride on a Facility

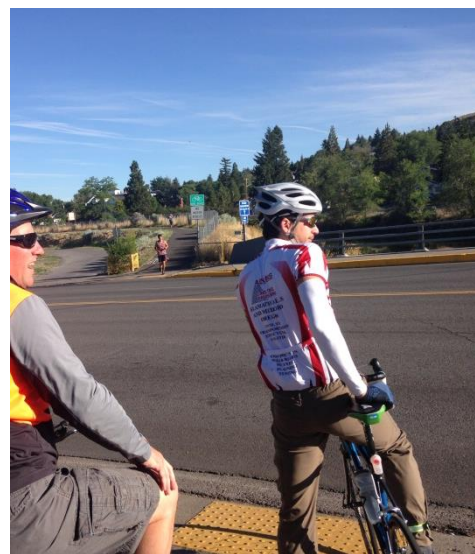
Unmarked "A" Canal Trail Crossing

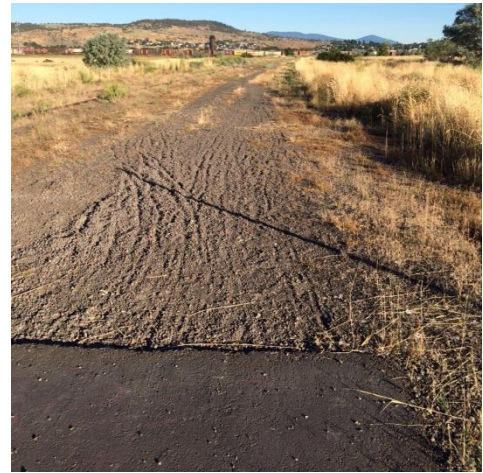
1. *OC&E Trail Connection to Downtown Klamath Falls* – The current TSP contains a planned project to extend the OC&E across the railroad tracks. Other options will also be examined.

End of the OC&E Trail

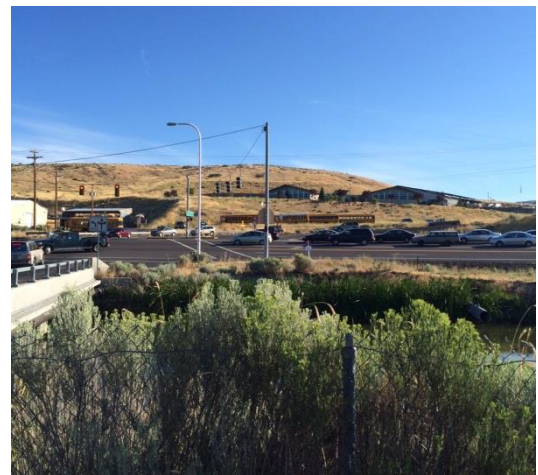
3. *Connecting the “A” Canal Trail to the Foothills Trail* – There is a short gap and a crossing of Crater Lake Parkway.
4. *Connecting the “A” Canal Trail to the Ella Redkey Swimming Pool* – The trail is grade separated from the pool.

No Connection from the “A” Canal Trail to the Foothills Trail

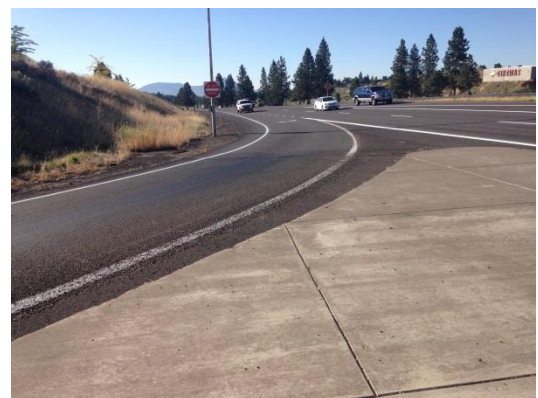
5. *Connecting the “A” Canal Trail to the Kiger Stadium and Klamath County Fairgrounds* – The trail is grade separated from these locations.
6. *Campus Trail to Biehn Street Connection* – There is a gap between the Campus Trail and the bike lane on Biehn Street, which connects to Oregon Avenue and downtown Klamath Falls.

Crater Lake Parkway Crossing Between Campus Trail and Biehn Street
