## Technical Memorandum #2: Existing and Future Conditions

### Gambell Street Redevelopment and Implementation Plan

Date: June 10, 2013 Project #:13489  
To: Paul Fuhs, Fairview Business Association  
From: Kelly Laustsen; Andy Daleiden, PE; Bob Kniefel, PE, and Marc Butorac, PE, PTOE; (Kittelison & Associates, Inc.) / Jim Potts, PE and Jordan Engel (CH2M Hill)  
cc: Project Management Team (PMT)

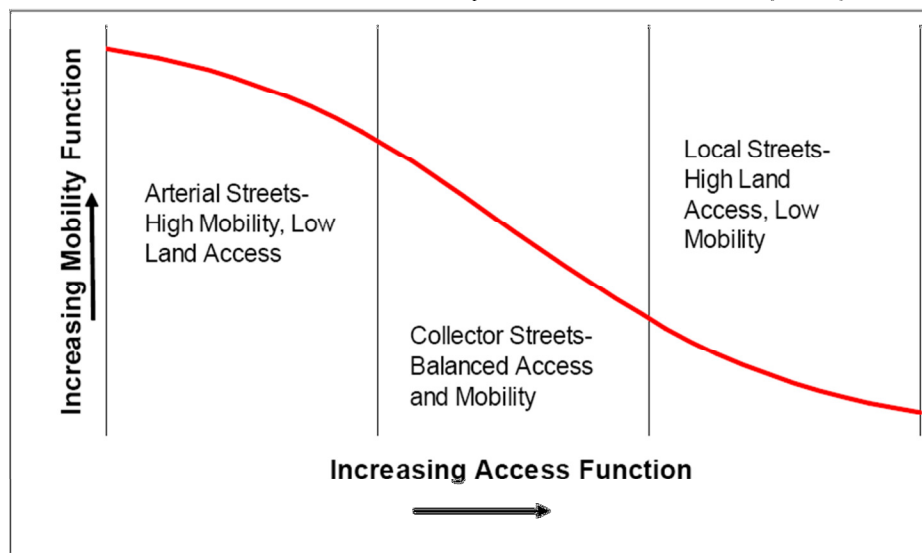
**Exhibit 1: Street Class Mobility and Access Functions (DCM)**

Gambell Street is classified as a Class IIIC Major Arterial, according to the *Official Streets and Highways Plan [11]*. Major arterials are intended to be a major facility for “moving larger volumes of inter-area traffic and for moving traffic to and from the freeway/express system” [11]. Therefore, access should be carefully controlled. Exhibit 1 illustrates the relationship between mobility and access by functional classification. Gambell Street was initially developed on a 60 foot ROW section approximately 80 years ago. Since that time, the street has substantially changed in its access function and use as the rest of Anchorage has grown up around Fairview.

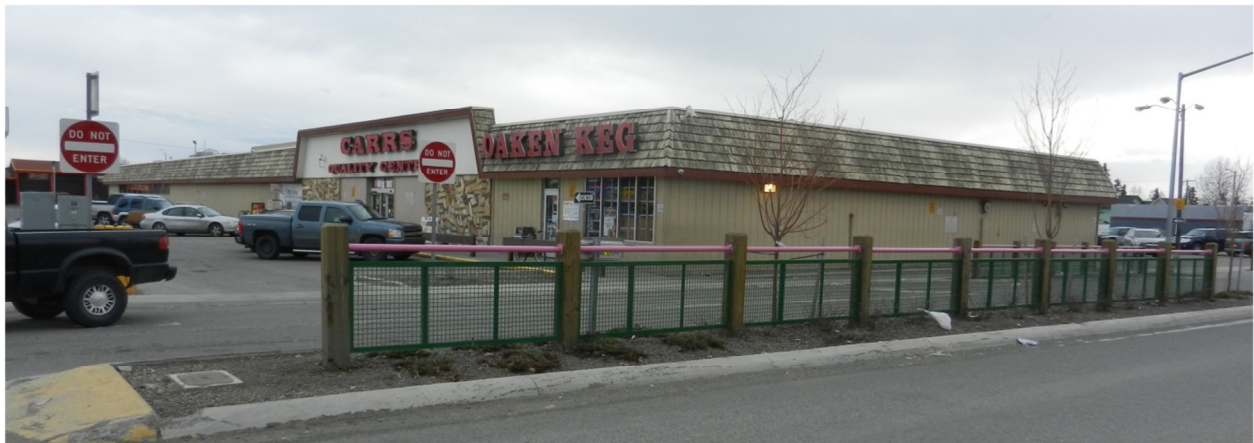
**Exhibit 2: Carrs/Safeway Grocery Store at Gambell Street/13th Avenue**

The existing land uses in the study area are shown in Figure 2. As seen in the figure, the primary land use immediately adjacent to the corridor is commercial. According to the Fairview Economic Revitalization Plan, the economic activity in Fairview includes a “mix of retail, banking, hotel, entertainment, restaurant, processing and manufacturing, light and heavy industrial, training, service, medical, professional and sports business” [3]. Carrs/Safeway grocery store, shown in Exhibit 2, is located at the intersection of Gambell Street/13<sup>th</sup> Avenue and is a significant generator of pedestrian and vehicle trips.

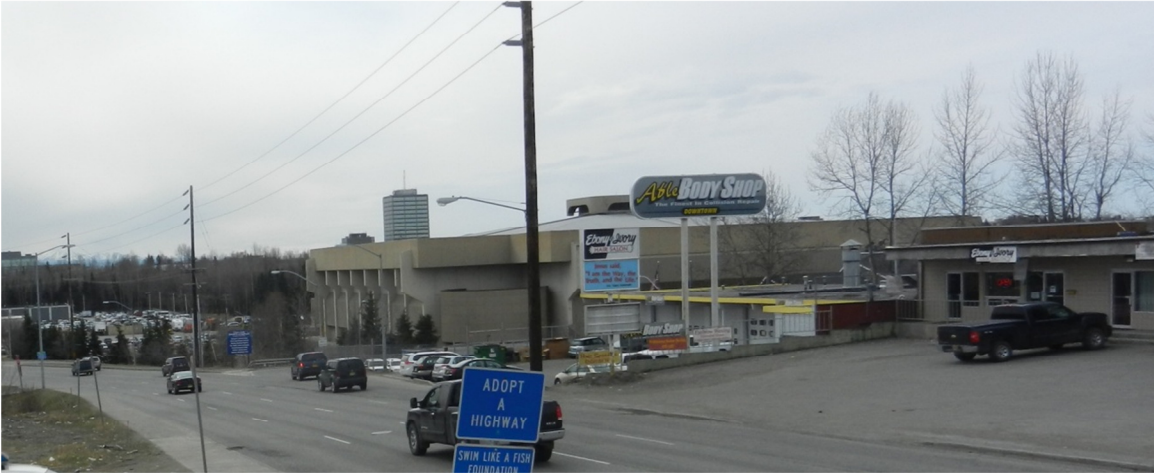
**Exhibit 3: View of Chester Creek Sports Complex from Gambell Street south of 15<sup>th</sup> Avenue**

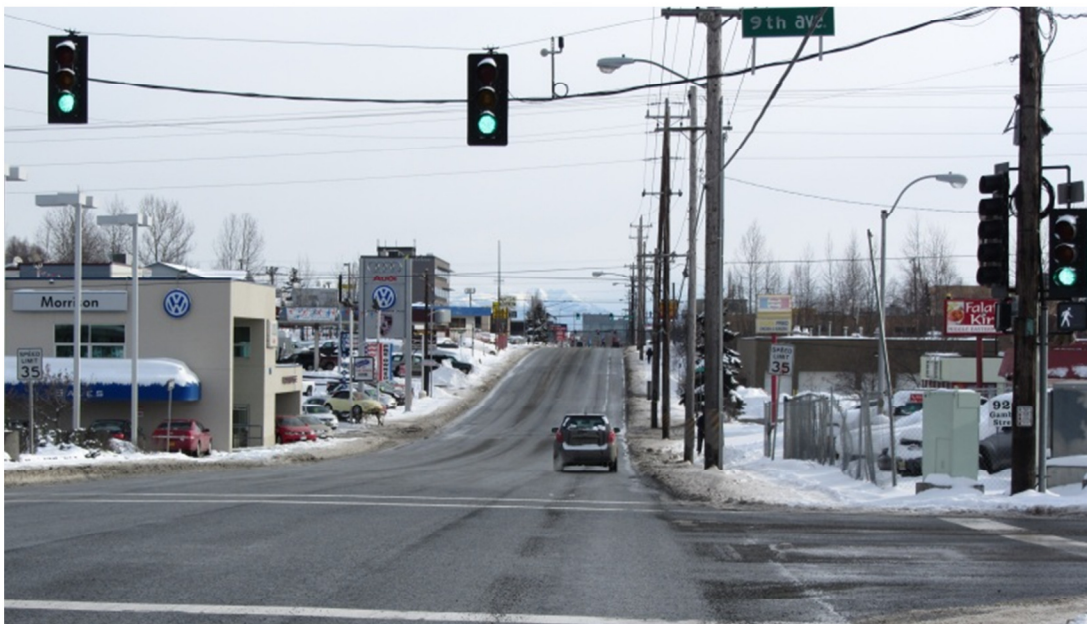
**Exhibit 4: View of Gambell Street looking South at 9<sup>th</sup> Avenue**

The existing uses on the corridor reflect these land use and zoning designations. As seen in the aerial provided in Figure 1 and image in Exhibit 4 below, Gambell Street in the study area is primarily composed of small to medium size freestanding businesses, with a few strip malls. In general, businesses or parking lots immediately abut the sidewalk. Utility poles run the length of the corridor on the west side of the roadway, with utility poles dividing the sidewalk approximately every 100 to 200 feet, as seen in Exhibit 5. There are no landscaping or aesthetic features on the corridor. As noted in FVCC’s Community Plan, “Landscaping is noticeably absent” [1]. The Fairview Economic Revitalization Plan notes the presence of “dilapidated structures” and vacant properties on the corridor [3].

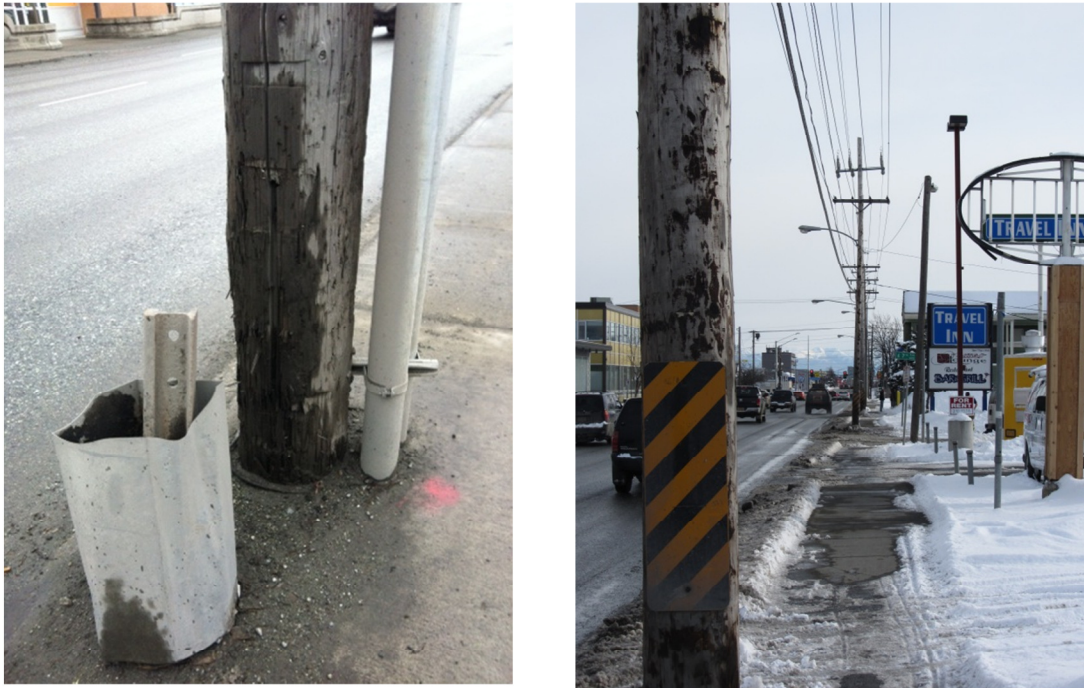
**Exhibit 5: Utility Poles on Gambell Street**

- **Pedestrian Facilities:** There are four- to six-foot sidewalks along the corridor and crosswalks at all signalized intersections. Power transmission lines/street light poles intersect the sidewalk along the corridor and some sections of the sidewalk are in poor repair, and do not meet ADA standards. There are no mid-block crossings or crosswalks at unsignalized intersections. The area has the highest percentage of non-motorized trips in Anchorage (20.5%).

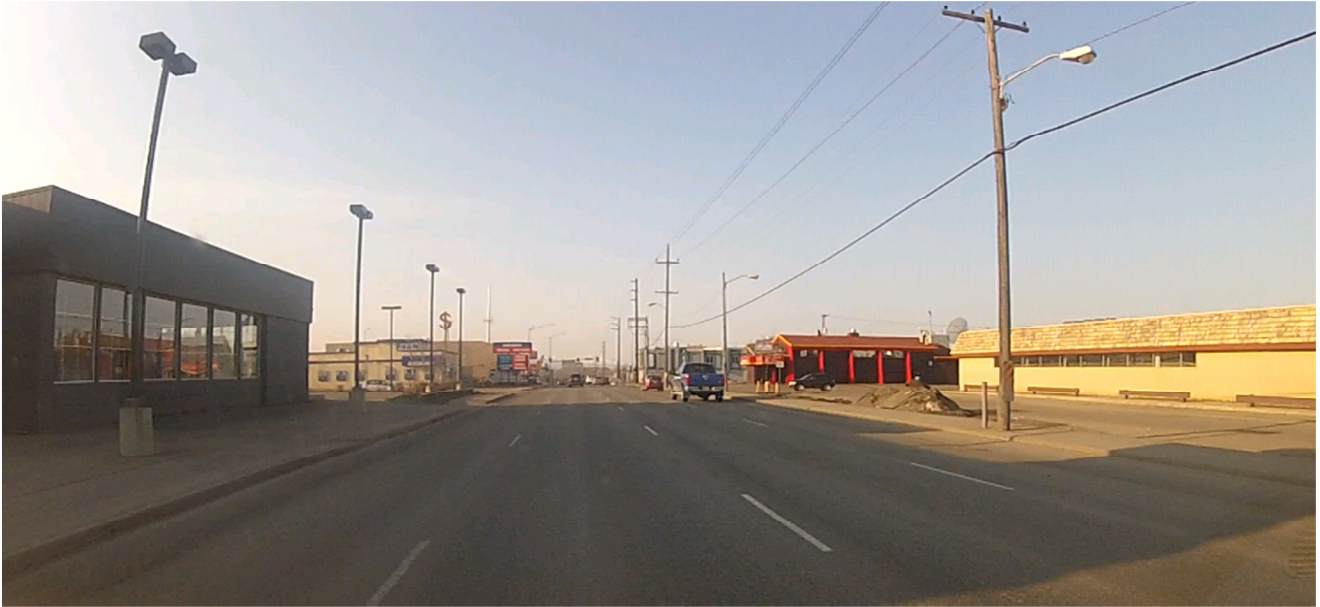
### Exhibit 6: Gambell Street South of 13<sup>th</sup> Avenue

As noted in the table, Gambell Street from 4<sup>th</sup> Avenue to its convergence with Ingra Street near 20<sup>th</sup> Avenue is a four-lane, one-way southbound roadway. Ingra Street forms the northbound component of the Gambell Street/Ingra Street couplet. The roadway has a right-of-way width of 60 feet. Exhibit 6 shows the typical facilities on the roadway in the study area and Exhibit 7 shows the roadway cross-section.

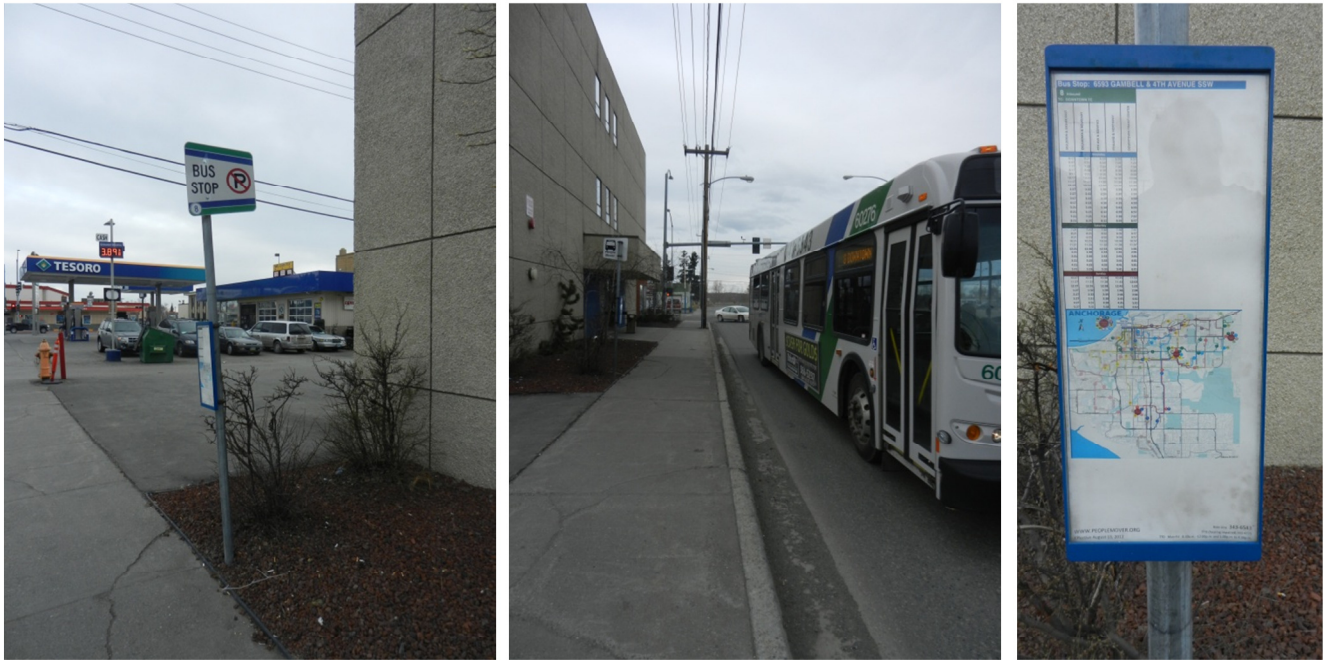
### Exhibit 8: Bus Stop Located at Gambell Street/4<sup>th</sup> Avenue

There is no transit service along the length of Gambell Street, although several routes cross the corridor and serve the area, including routes 8, 45, 102, 13, and 15. Route 8 runs along Gambell Street between 3<sup>rd</sup> Avenue and 5<sup>th</sup> Avenue and stops on the west side of Gambell Street south of 4<sup>th</sup> Avenue, shown in Exhibit 8. Figure 3 shows the transit routes in the vicinity of the corridor.

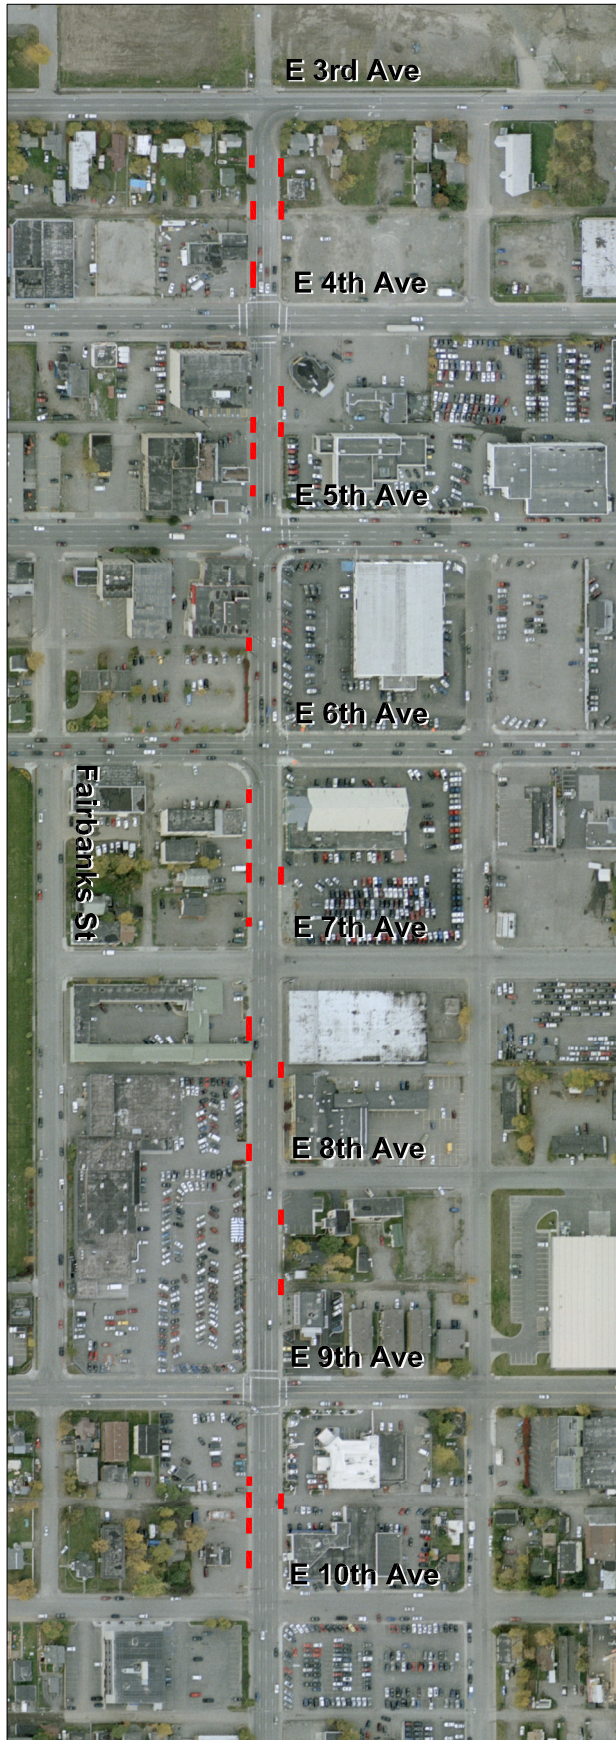
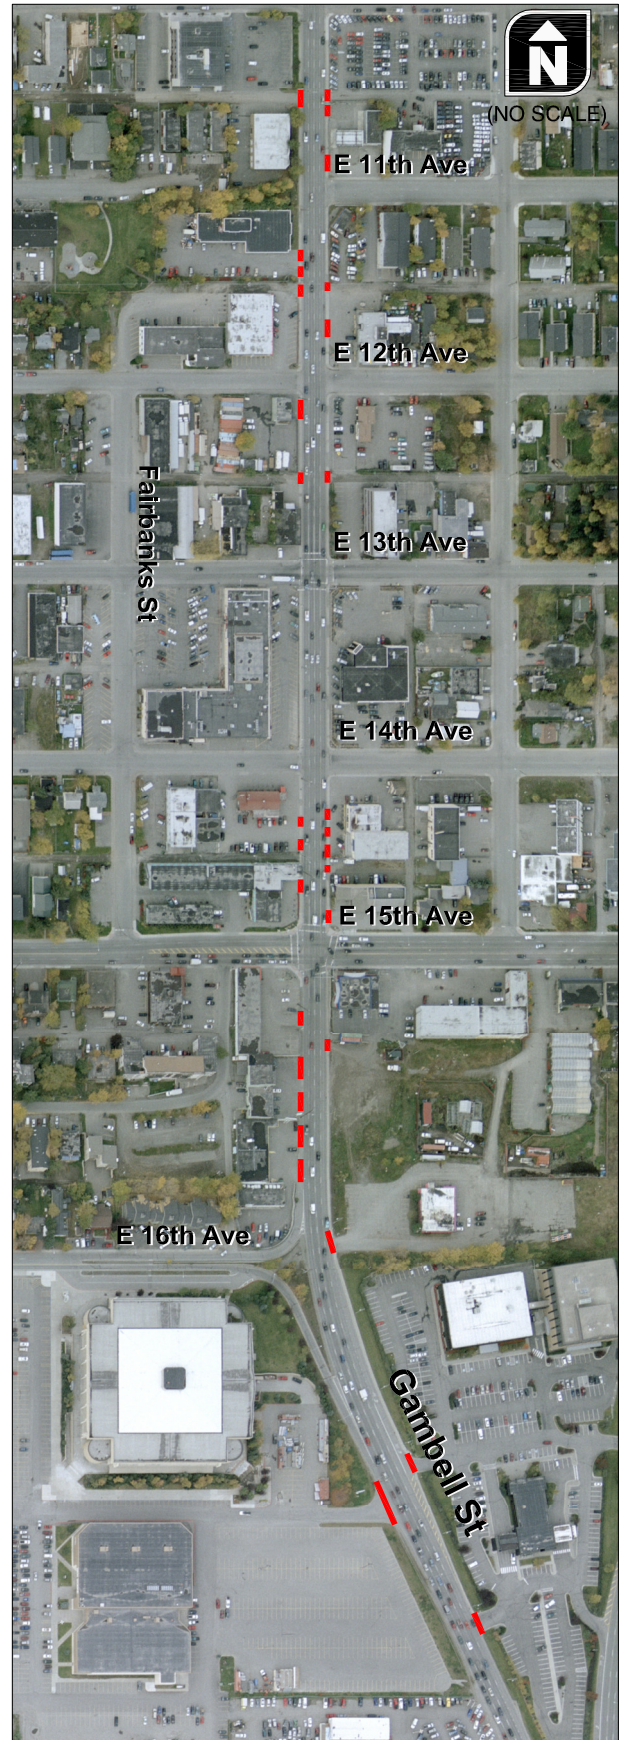
**Figure**  
**4**

A field inventory of the existing accesses, public streets, and businesses was conducted on Gambell Street through the study area. Figure 4 shows the accesses to existing businesses in the study area, with driveways noted in red. As seen in the figures, there is a high density of accesses along the corridor. The driveways do not have dedicated turn lanes. As observed during field visits, the turning vehicles can slow traffic speeds in the left and right lanes on Gambell Street and create speed differentials with the two interior lanes. The driveway spacing standards on the corridor are provided in the *Alaska Highway Preconstruction Manual* [10] and described in the “Background” section of this report. A high-level comparison of the standards and existing driveway spacing was performed. In general, the quantity of driveways is greater than typical on a major arterial, which is intended to have a high mobility function. Access management strategies will be considered in the next stage of the project.

Existing Driveways

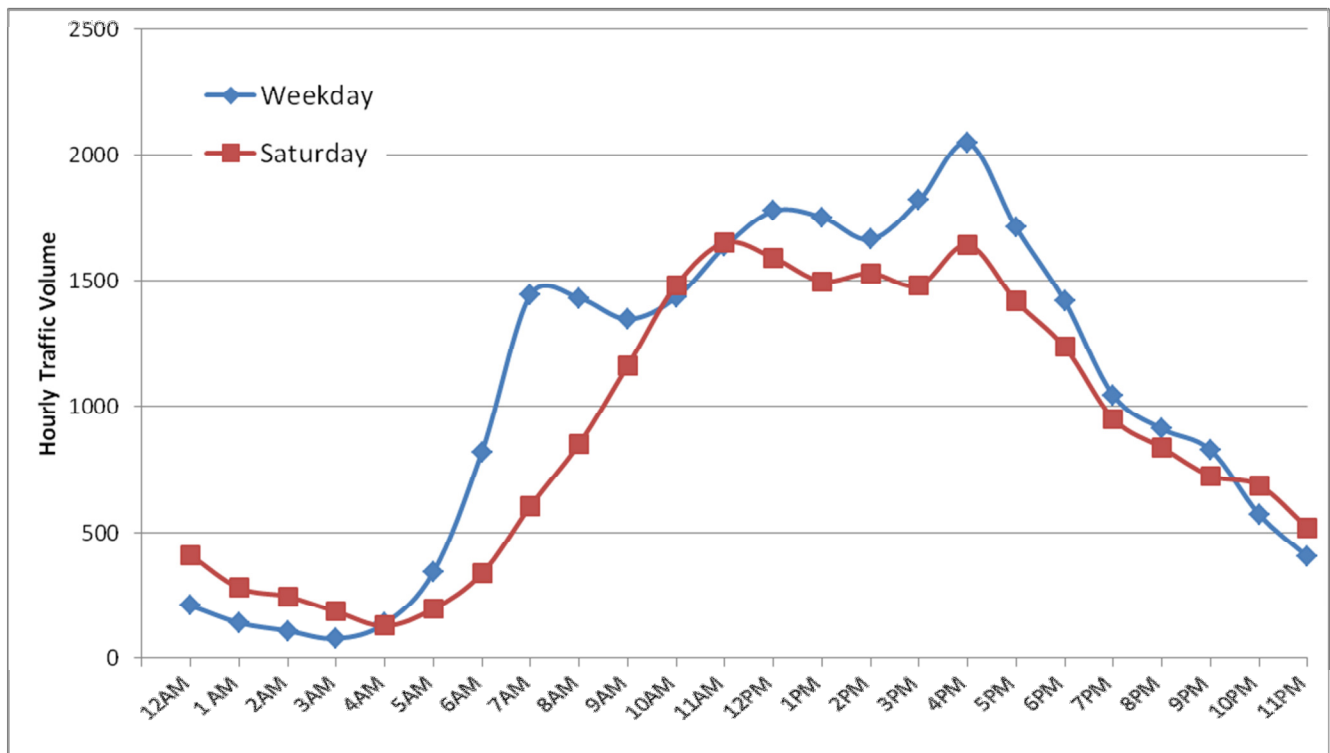
**Exhibit 9: Daily Traffic Profile on Gambell Street (near Chester Creek)**

DOT&PF maintains a daily traffic recorder at Gambell Street/Ingra Street/20<sup>th</sup> Avenue. The volumes at this recorder for the first week of June 2013 were collected to better characterize traffic volumes on the corridor throughout the day. A weekday and Saturday profile by hour of vehicle traffic on Gambell Street is provided in Exhibit 9.

As seen in the exhibit, weekday traffic volumes generally rise throughout the day and peak in the early evening. There is also a slight morning peak around 7 AM and midday peak around noon. Saturday traffic volumes are highest between 11 AM and 4 PM. Total traffic volumes are about 25,000 vehicles for a weekday and 22,000 vehicles on a Saturday.

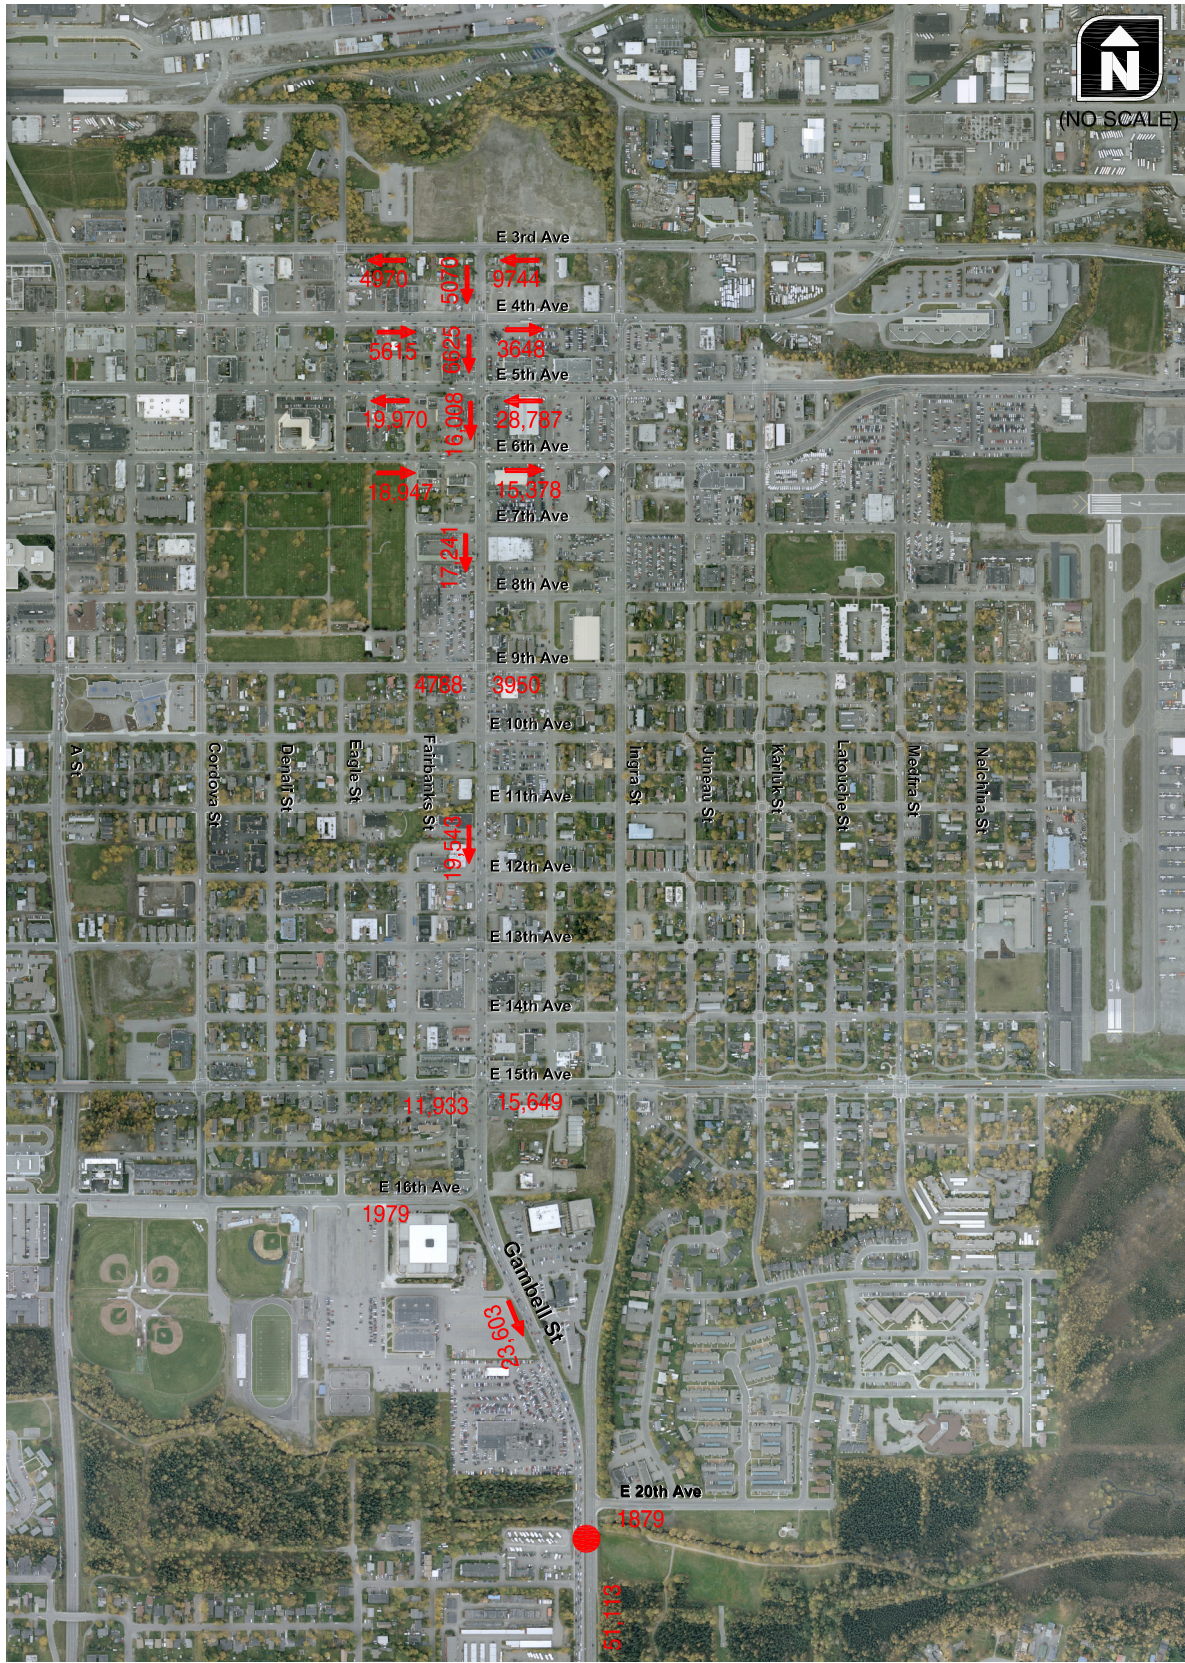
Figure 5 notes the average annual daily traffic (AADT) volumes on the study corridor according to the Annual Traffic Volume Report [14] produced by DOT&PF. As seen in the figure, traffic volumes increase significantly from the northern portion of the corridor to the southern portion of the corridor. Also, Gambell Street has higher traffic volumes during the PM peak than during the AM peak.

Year 2011 Average Daily Traffic Volumes

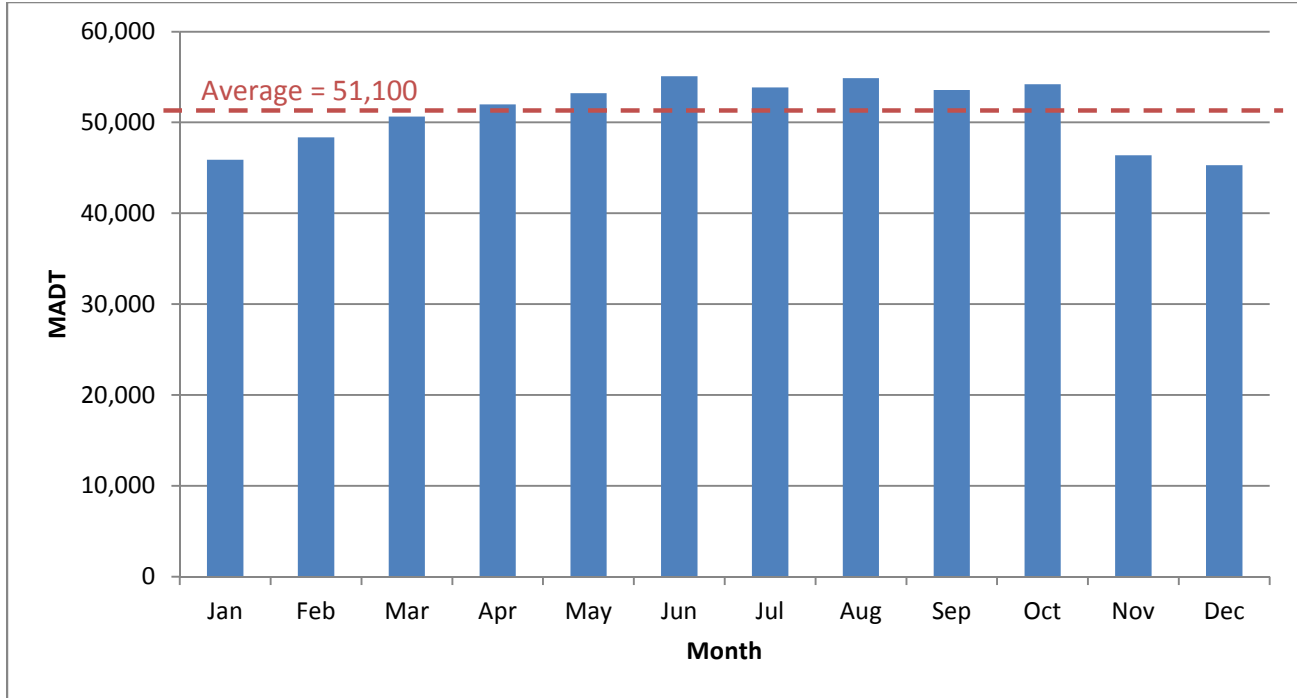
**Exhibit 10: Average Two-Way Daily Traffic by Month (Ingra and Gambell at Chester Creek) [14]**

In addition, traffic counts at the station were assessed by month to identify seasonal trends on the corridor. A profile of two-way daily traffic volumes at the station by month is provided in Exhibit 10.

As seen in the graph, daily traffic volumes rise steadily from January to July, stay relatively constant through October, and drop slightly in November and December. For this analysis, traffic counts were taken in May 2013. Based on the data from 2011, traffic volumes in May are slightly higher than average. Therefore, the operations assessment likely reflects higher than typical traffic volumes.

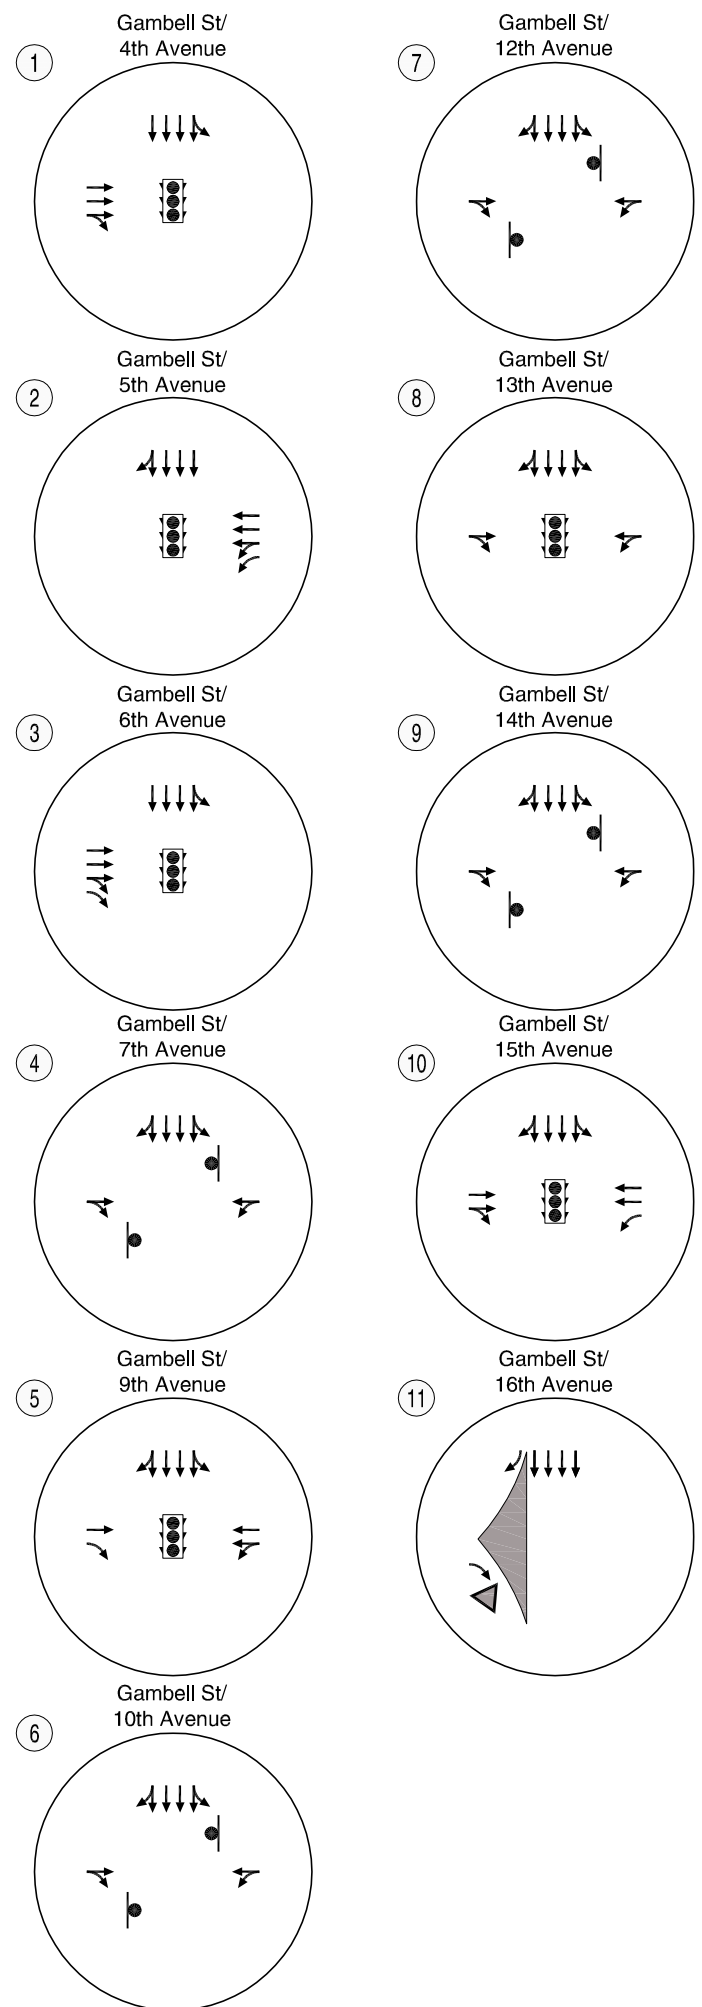
**Figure 6**

Signal timing for these intersections was provided via a Synchro file and text files from the Traffic Engineering Division of the Municipality of Anchorage. The other study intersections are two-way-stop-controlled, with the cross-street approaches stop-controlled. Figure 6 shows the existing lane configuration and traffic control devices at the intersections.

**Existing Lane Configurations and Traffic Control Devices**

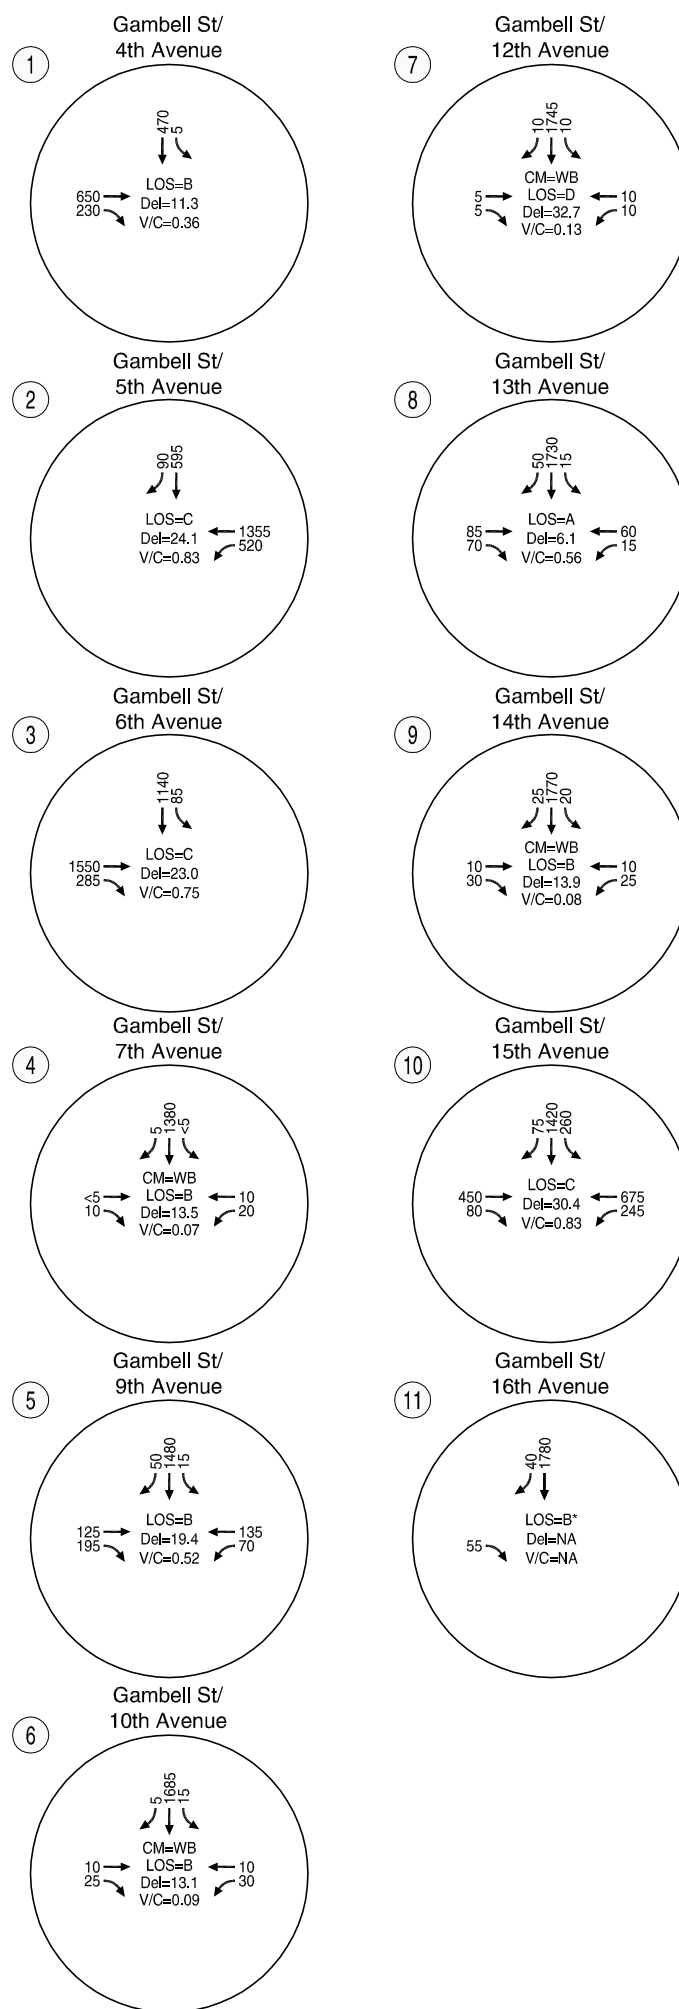
**Figure  
 7**

CM = CRITICAL MOVEMENT (UNSIGNALIZED)  
 LOS = INTERSECTION LEVEL OF SERVICE (SIGNALIZED)/CRITICAL MOVEMENT LEVEL OF SERVICE (UNSIGNALIZED)  
 Del = INTERSECTION AVERAGE CONTROL DELAY (SIGNALIZED)/CRITICAL MOVEMENT CONTROL DELAY (UNSIGNALIZED)  
 V/C = CRITICAL VOLUME-TO-CAPACITY RATIO  
 \* ANALYSIS BASED ON 2010 MERGE METHODOLOGY

**Existing Traffic Operations  
 Weekday PM Peak Hour**

- **Intersection Operations:** A variety of data was utilized for the operations analysis, including existing traffic counts at several intersections on the corridor (at 4th, 6th, and 9th), as well as turning movement counts conducted during the PM peak hour on a typical mid-week day in early May 2013. Based on this data, all intersections are currently operating at LOS C or better during the weekday PM peak hour, with the exception of the intersection of Gambell Street/12<sup>th</sup> Avenue, where the westbound stop-controlled approach is operating at a LOS D. It should also be noted that some congestion is experienced on the corridor between approximately 11<sup>th</sup> and 16<sup>th</sup> Avenues during special events at the Chester Creek Sports Complex.

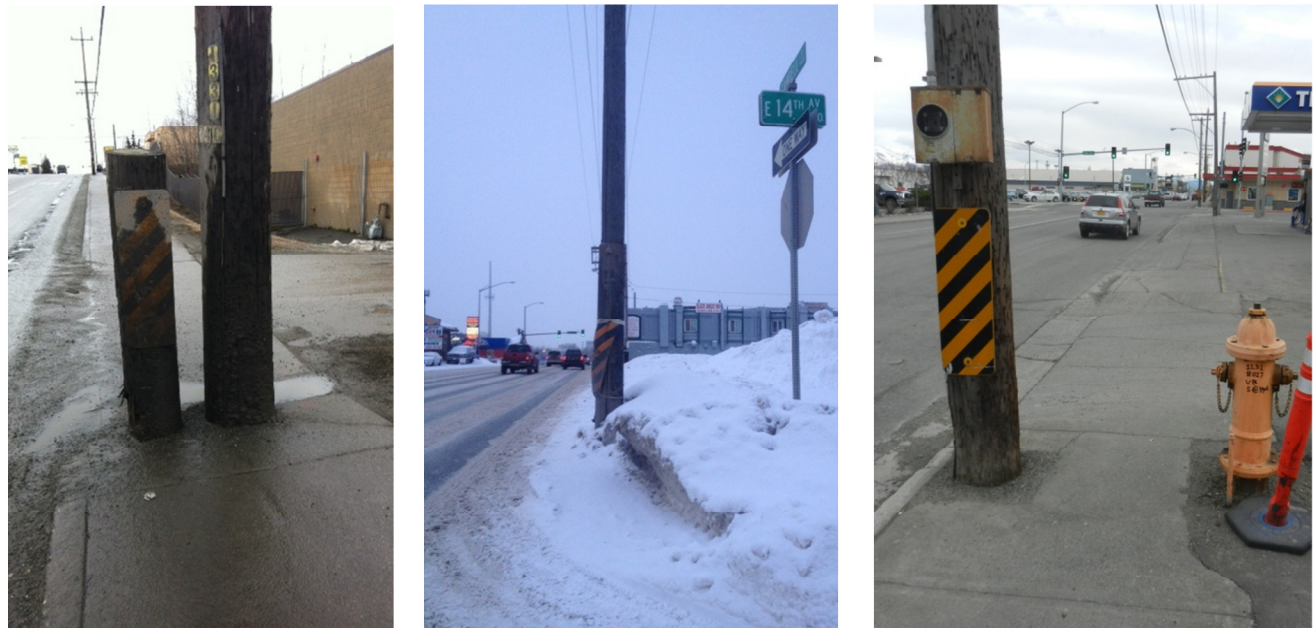
### Exhibit 11: Sidewalk Conditions on Gambell Street

lefts. These factors were considered in combination with the conditions observed during field visits to the corridor. While there are four- to six-foot sidewalks along the length of the corridor on both sides of the roadways, there are several conditions that degrade the pedestrian LOS. The sidewalks are disrupted by electrical transmission lines/street light poles and in general are in poor condition. There is no shoulder between the sidewalk and the outside vehicle travel lanes. There are driveways along the corridor that interrupt the pedestrian traversing the existing sidewalk system.

The majority of sidewalks along the corridor are not up to ADA standards, and particularly difficult for pedestrians to navigate in winter conditions. The images in Exhibit 10 illustrate the poor pedestrian facilities on the corridor.

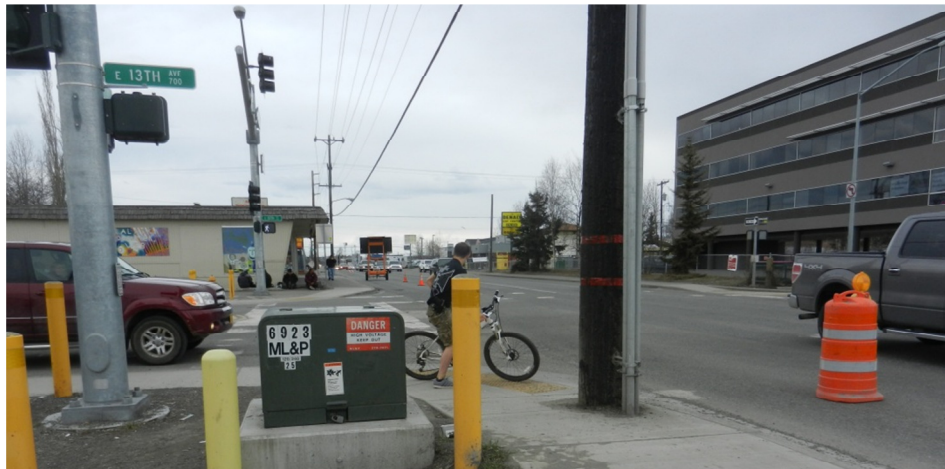
**Exhibit 12: Bicyclist on Sidewalk at Gambell Street/13<sup>th</sup> Avenue**

Bicycle LOS is based on the vehicular volume of traffic on the roadway, the pavement conditions, and the number and width of traffic lanes and bike lanes. The corridor has relatively high volumes and speeds of vehicular traffic and no shoulder or bike lanes. Therefore, it can be concluded that bicycle LOS is relatively poor. Several bicyclists were observed riding on the sidewalk or crossing the street through the crosswalks, as shown in Exhibit 12, further indicating the lack of comfort that bicyclists feel on the corridor. The bicycle intersection counts revealed a low level of bicycle activity, with no more than 5 bicyclists counted at any intersection during the PM peak hour.

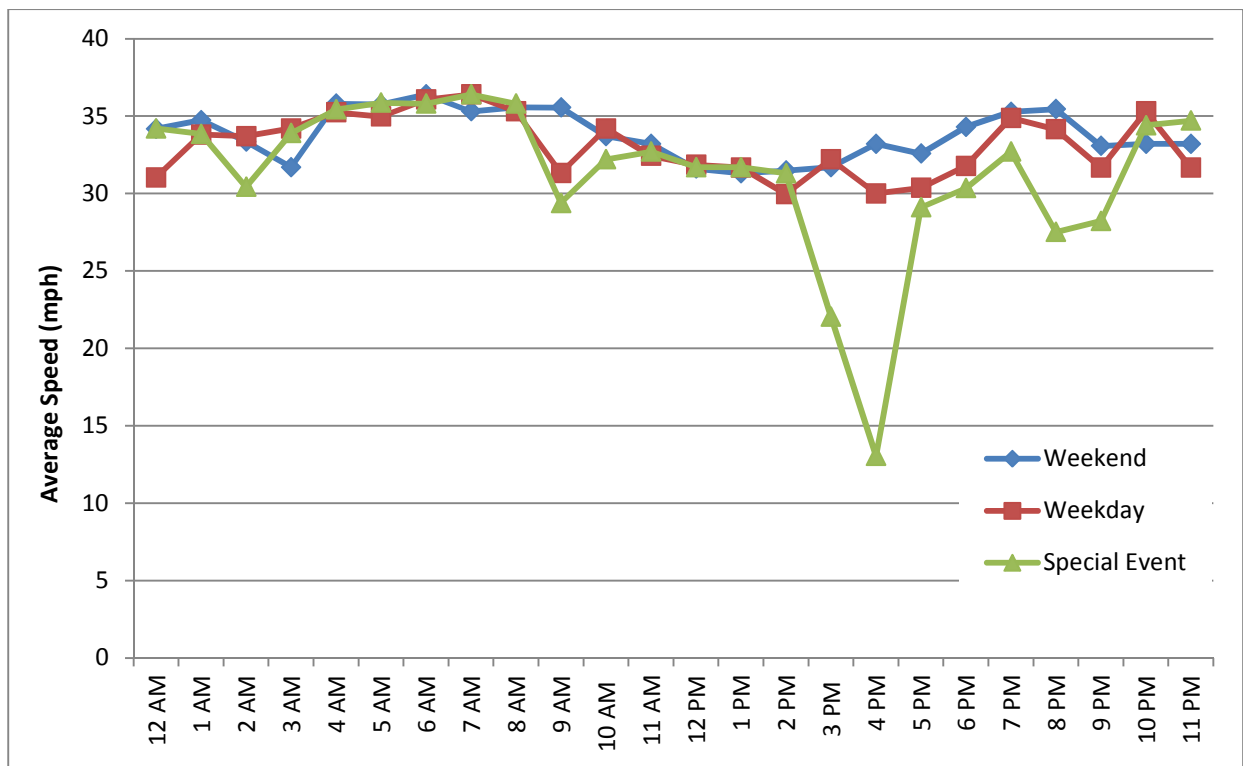
**Exhibit 13: 85th Percentile Speeds on the Corridor**

The posted speed limit on the corridor is 35 miles per hour. Speed data was collected on the corridor between 7<sup>th</sup> Avenue and 16<sup>th</sup> Avenue for two weeks in early to mid-May to assess typical speeds through the weekday, weekend, and during special events. Speeds are generally analyzed in terms of the 85<sup>th</sup> percentile speed, which is the speed which no more than 15% of traffic is exceeding. The 85<sup>th</sup> percentile speed is generally used when setting speed limits. Exhibit 13 provides a profile of 85<sup>th</sup> percentile speeds on the corridor for the weekday, weekend, and special event.

As seen in Exhibit 12, 85th percentile speeds on the corridor are relatively constant throughout the day during the weekend and on weekdays. Speeds dip slightly during the morning and afternoon peak hours, but in general are within a few miles of the posted speed limit of 35 miles per hour. This suggests that the speed limit is appropriate and generally abided by. Field visits to the site corroborated the data collected. While slower speeds and congestion were witnessed on Gambell Street south of the corridor, in general observed speeds on the corridor were within a reasonable range of the posted speed limit.

The “Special Event” speed data shown in Exhibit 12 is an average of data collected during the graduation week of May 13<sup>th</sup>. Graduation ceremonies were held at the arena at 2:00 PM and 7:00 PM. As seen in the exhibit, 85<sup>th</sup> percentile speeds on the corridor dropped after these events for a few hours, most noticeably between 2 and 4 PM. This corroborates what was witnessed during field visits to the corridor during this time.

- **Speeds:** In general, 85<sup>th</sup> percentile speeds on the corridor are between 30 and 35 miles per hour, which is consistent with the posted speed limit on the corridor of 35 miles per hour. Slower speeds were observed following special events at the Sullivan Arena.
- **Crash History:** There were no fatal reported crashes on the corridor between 2007 and 2011. The most common crash types are angle and rear-end, and the most crashes were observed at the intersections of 5<sup>th</sup>, 6<sup>th</sup>, 9<sup>th</sup>, 13<sup>th</sup>, and 15<sup>th</sup>. The most prevalent human contributing causes were driver inattention, unsafe speed, and red-light violation.

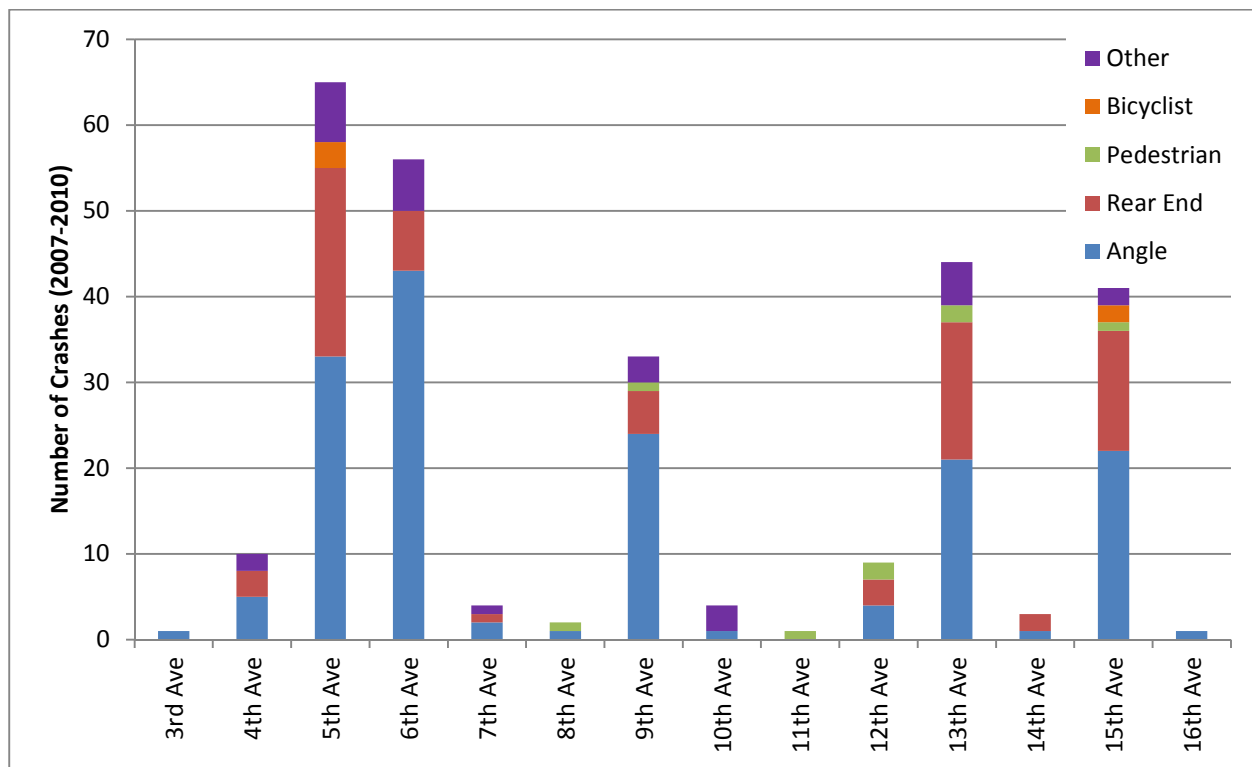
**Exhibit 14: Crashes by Location and Type (2007-2010)**

This data is also displayed graphically in Exhibit 14 to better visualize the location of crashes.

As seen in the table and exhibit, the highest crash locations on the corridor are:

- Gambell Street/5<sup>th</sup> Avenue (65 reported crashes, including 3 bicyclist crashes);
- Gambell Street /6<sup>th</sup> Avenue (56 reported crashes, with a majority of angle crashes);
- Gambell Street /13<sup>th</sup> Avenue (44 crashes, including 2 pedestrian crashes);
- Gambell Street /15<sup>th</sup> Avenue (41 crashes, including 1 pedestrian and 2 bicyclist crashes);
- and
- Gambell Street /9<sup>th</sup> Avenue (33 crashes, with a majority of angle crashes).

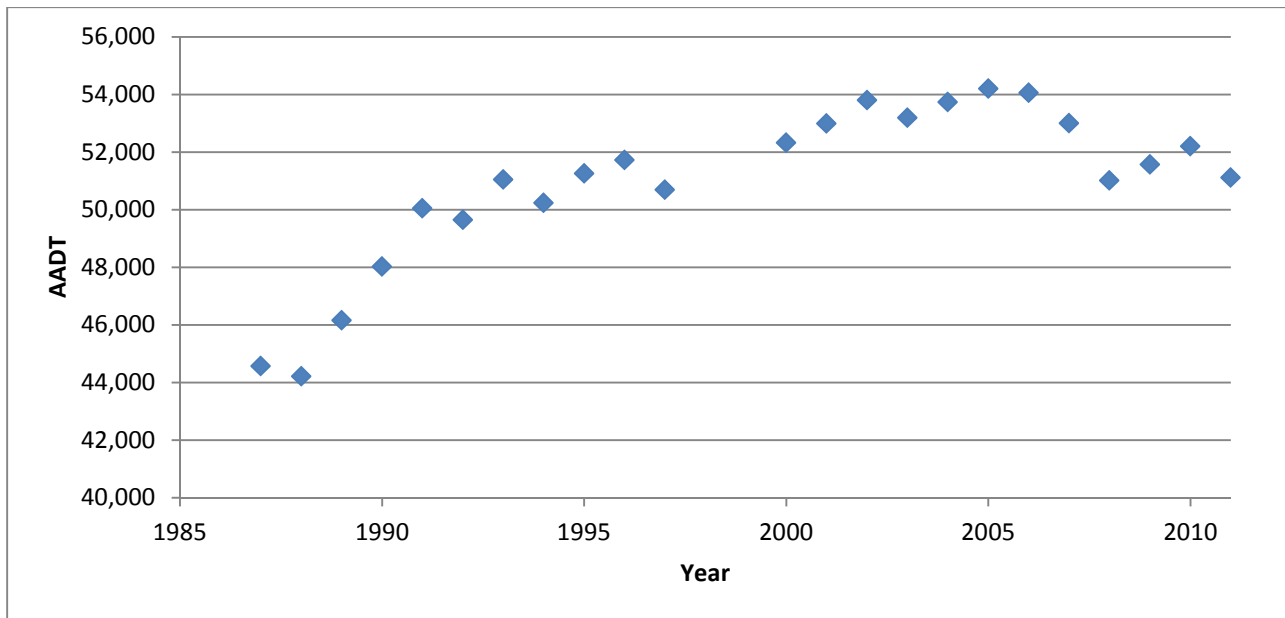
**Exhibit 16: Historical AADT data at Gambell St/Ingra St/15<sup>th</sup> [14]**

Future traffic volumes were developed based on an assessment of historical growth on the corridor and the 2035 MTP model projections. The permanent traffic recorder located at Ingra Street and Gambell Street near Chester Creek has AADT information available from 1987 through 2011. This data is shown in Exhibit 16.

As seen in the graph, overall traffic volumes on the corridor generally increased up until 2006, before dropping off through 2008. Traffic volumes again grew from 2008 through 2010 before dipping in 2011. On average, traffic volumes grew about 0.6% annually between 1987 and 2011.
